# QUALITY PROBLEM ANALYZE

**HANISUGI**  
JAPAN

WHEELS

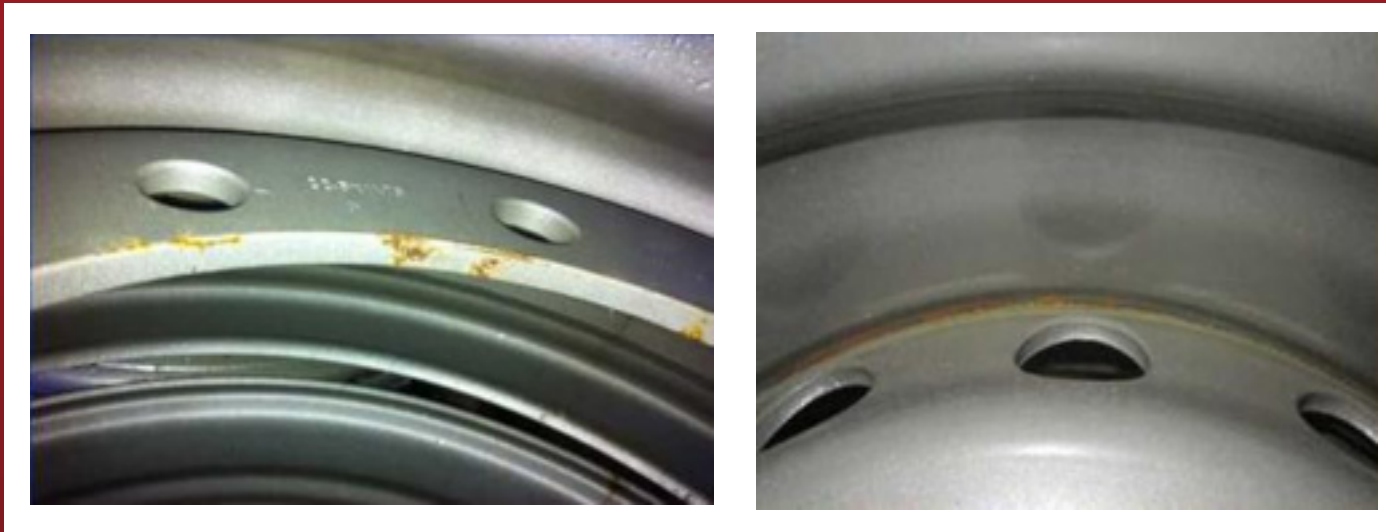
# 1.

**A. Rust**, the wheels surface against and the surface broken will be caused the surface rust, also Poor storage environment can caused the surface rust

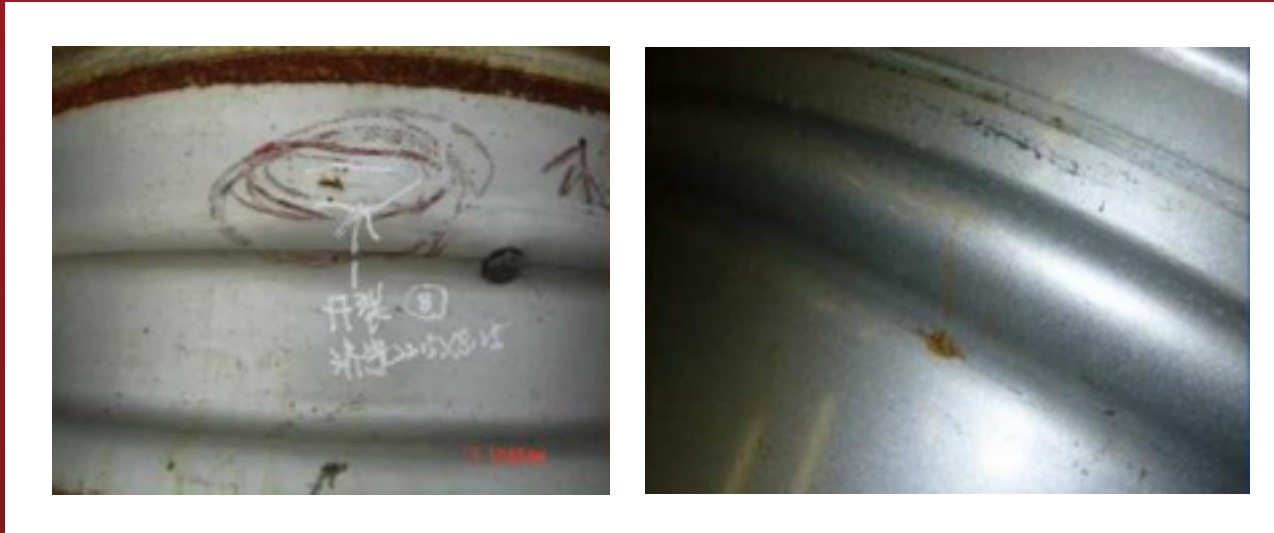
# 2.

**A. Wheels lateral fatigue crack(air leak):** wheel overload, partial load, poor road condition, driving road bumps

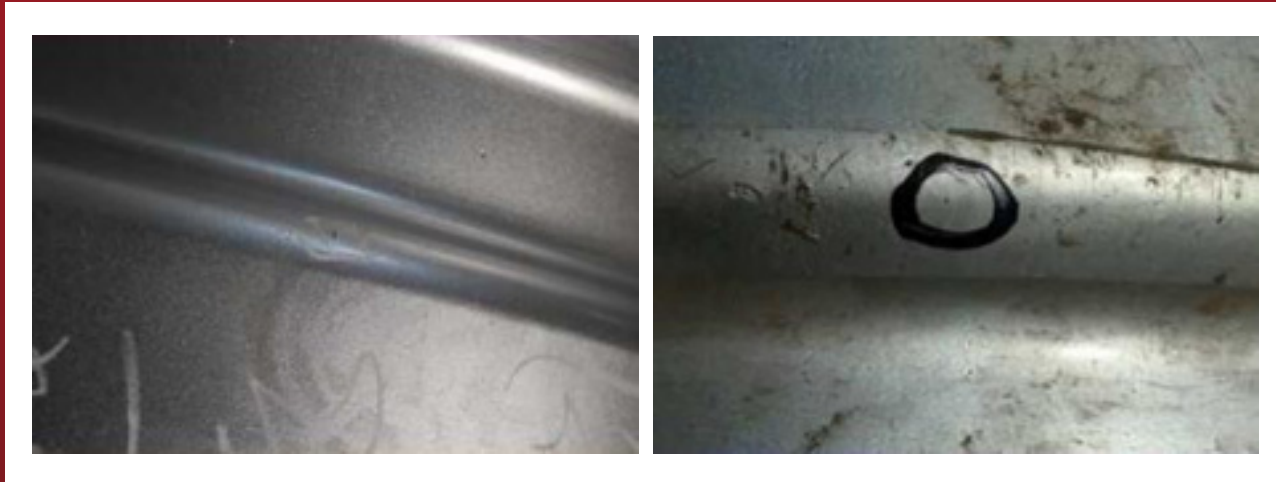
# 2.

**B. the welding broken:** during the production, the welding not good.

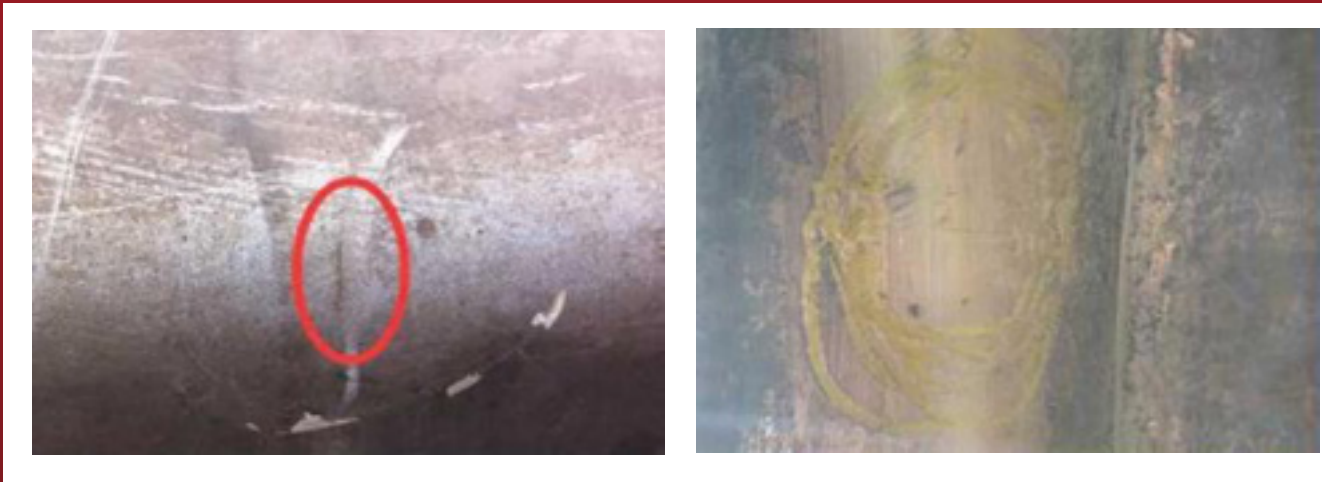
# 2.

**C. Wheels welding (air leak):** wheel overload, partial load, poor road condition, driving road bumps.

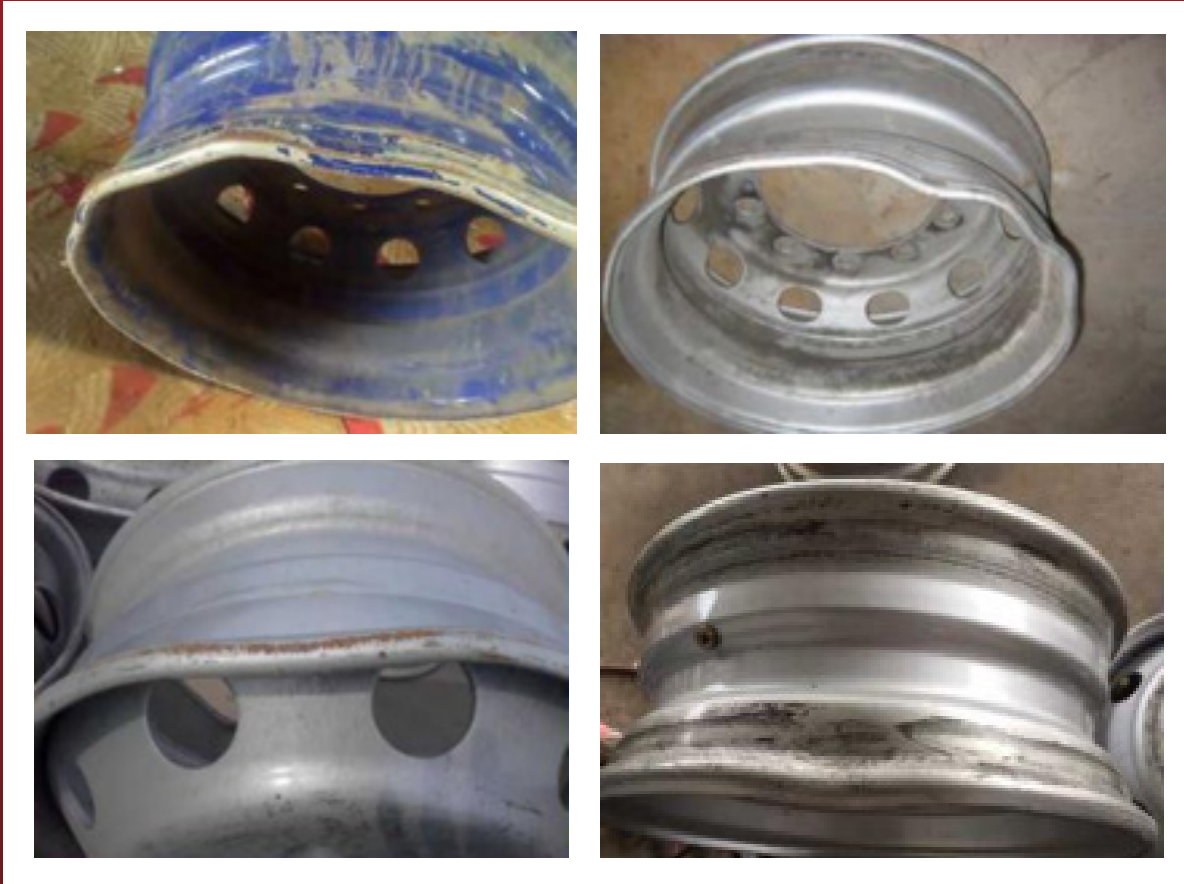
# 3.

**A. The rim out of the shape,** wheels overload, poor road conditions, The driver's bad driving habits, sudden braking , or the air pressure exceeds the rated air pressure

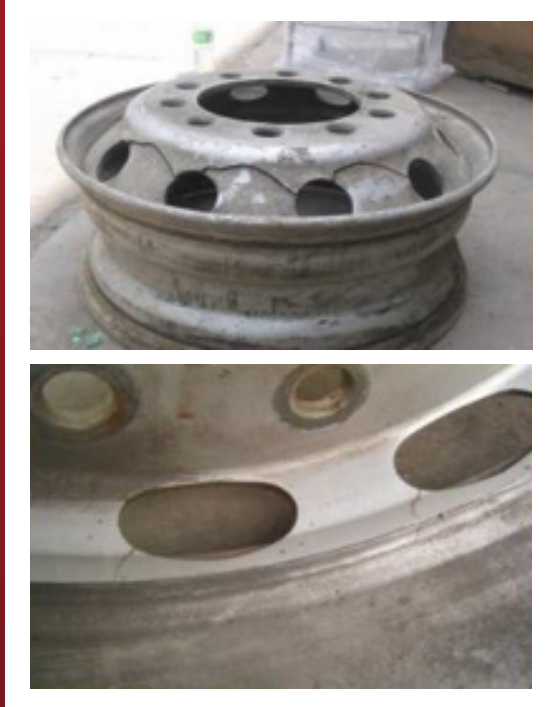
# 4.

**A** .Dis broken, wheels overload, poor road condition, sudden braking.

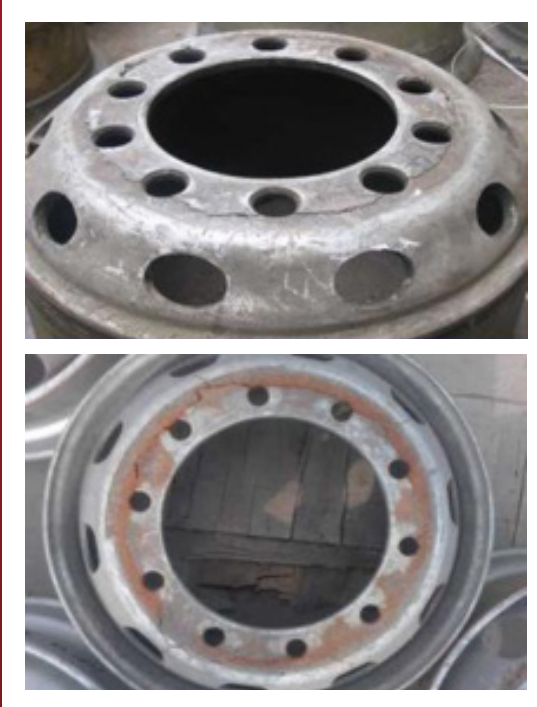
**B** .**The bolt hole crack:** Nut looseing, resulting in uneven bolt hole stress, wheel overload, insufficient tire pressure or careless driving,

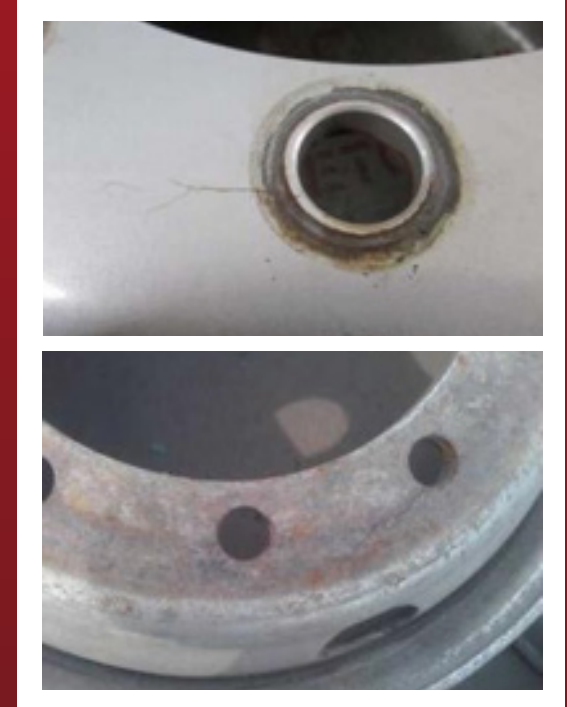
**C** .**Fatigue cracking of bolt hole:** the installation is not in place, the bolt torque is not enough or all the bolt torque is not uniform

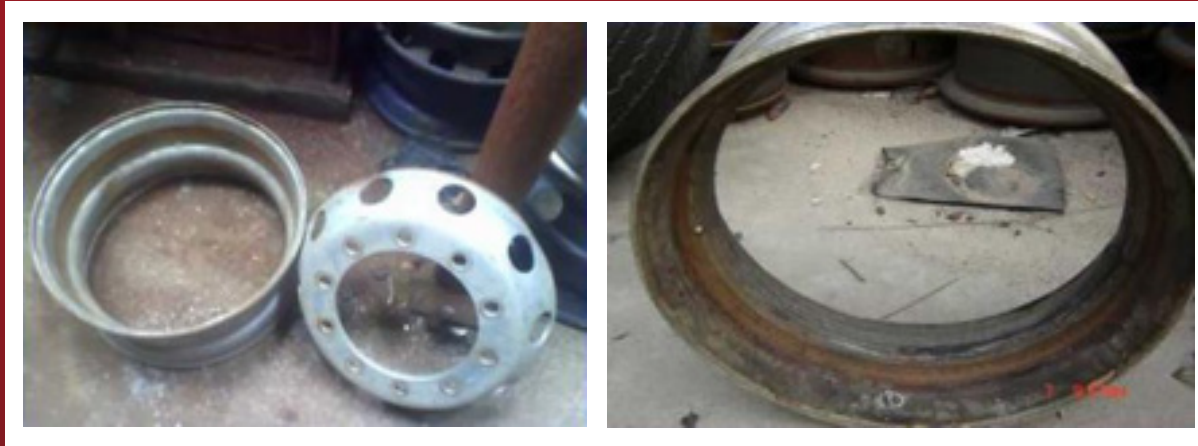
# 5.

**A. Welding:** out of welding, rims and disc are all not any broken, it means the problem is caused by the production welding
